**California Regional Water Quality Control Board
Central Coast Region**

**Total Maximum Daily Loads for Fecal
Coliform in the Pajaro River Watershed
Including, Pajaro River, San Benito River,
Llagas Creek, Tequisquita Slough, San Juan
Creek, Carnadero/Uvas Creek, Bird Creek,
Pescadero Creek, Tres Pinos Creek, Furlong
(Jones) Creek, Santa Ana Creek, and
Pachecho Creek, in Santa Cruz, Santa Clara,
San Benito, and Monterey Counties,
California**

Phase-5: Regulatory Action Selection

**Final TMDL Project Report
December 2008**

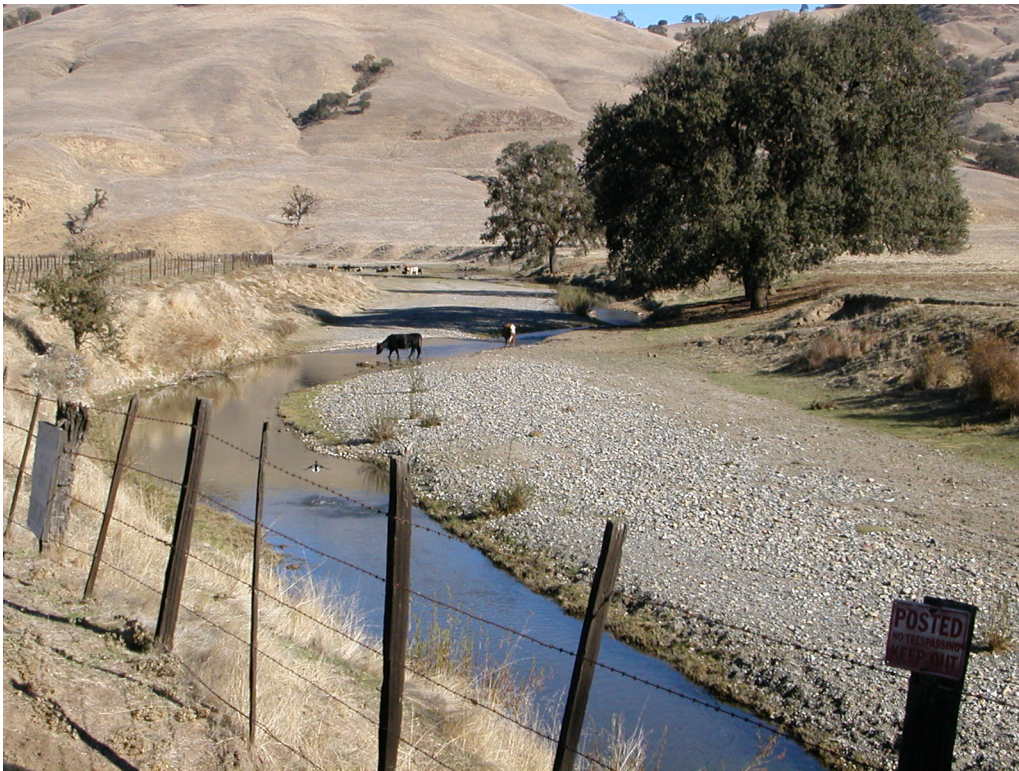
Figure 5-1. Cattle within San Benito River upstream of monitoring station 305SBA. (Water Board staff photograph, Nov. 6, 2006)

FIB sources from open spaces that are grazed, in part, originate from cattle feces entering the water body. Staff observed cattle within the San Benito River and cattle grazing adjacent to San Benito River, Pajaro River, Tequisquita Slough, and most tributary streams (e.g. Pachecho Creek, Tres Pinos Creek, San Juan Creek, and Uvas Creek). *E. coli* values up to 61,000 MPN/100 ml were recorded at monitoring station 305SBA, where staff observed cattle in San Benito River (Figure 5-1). Staff acknowledges the possibility that FIB levels at monitoring site 305SBA may be from natural sources, such as wild pig or other wildlife, however staff noted the presence of cattle in the river during most monitoring events. In addition, the California Food Emergency Response Team (CalFERT)

Staff concluded that cattle grazing lands are a source contributing to exceedances of water quality objectives. Actions to control these sources are included in Section 12 Implementation Plan.

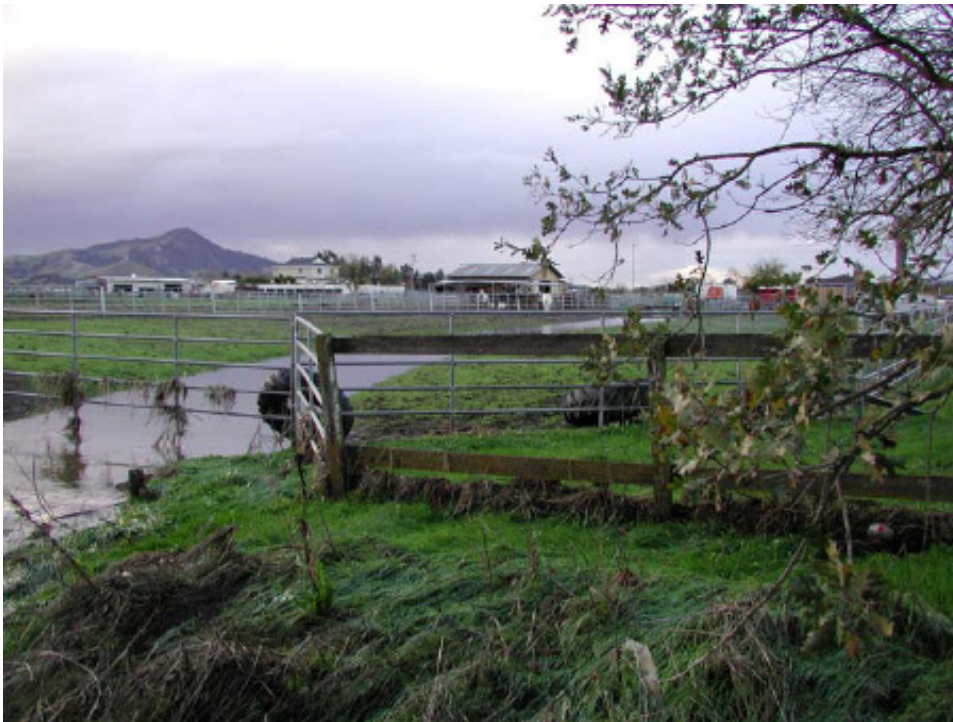
Figure 5-2. East Little Llagas Creek in rural residential pastures west of Llagas Avenue. (Fall Creek Engineering, Inc., 2004).

Staff observed many farm animal operations within the Pajaro River watershed. These operations (commonly referred to as “hobby farming” or “hobby ranching”) are located in rural residential areas where farm animals and livestock such as horses, cattle, chickens, goats, dogs, cats, and other farm animals are housed. These animals may contribute FIB if manure is not properly managed (e.g., retained on site) or if farm animals have access to waterways. Staff observed farm animals in rural areas that are adjacent to impaired reaches and tributary streams throughout most non-urban portions the Pajaro River watershed. *E. coli* values up to 130,000 MPN/100 ml were recorded at monitoring station 305SJN, where staff observed cattle and horses on rural residential properties next to San Juan Creek.
